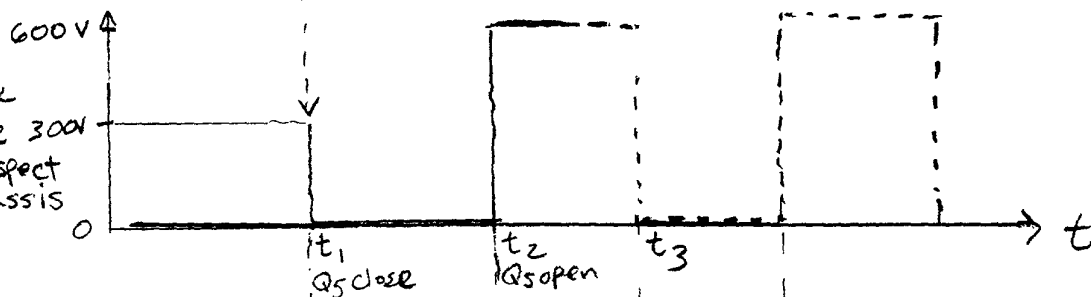
FIG. 2A

(+) DC Link  
Voltage 300V  
With Respect  
To Chassis

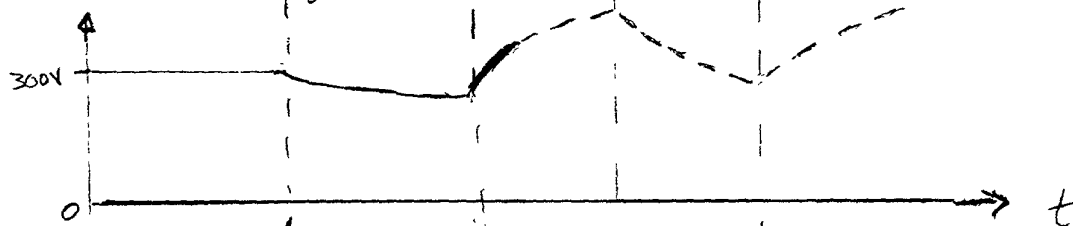
FIG. 2B

$V_{C2}$   
across  
capacitor  
C62

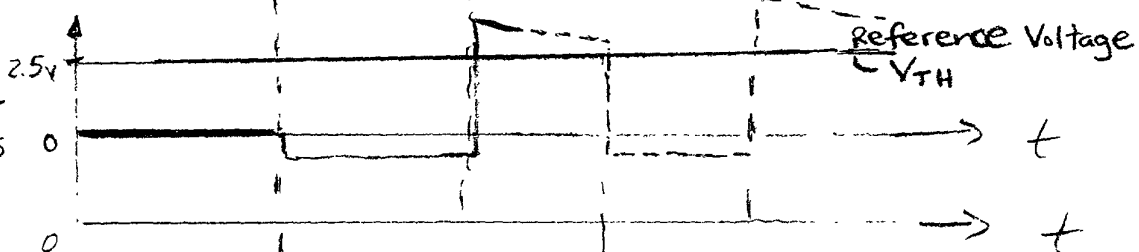
FIG. 2C

$V(t)$   
Comparator  
with Respect  
To Chassis

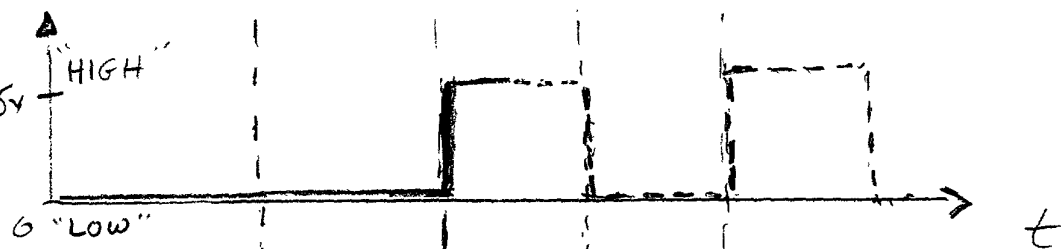
FIG. 2D

Comparator  
output  
Voltage  
Signal

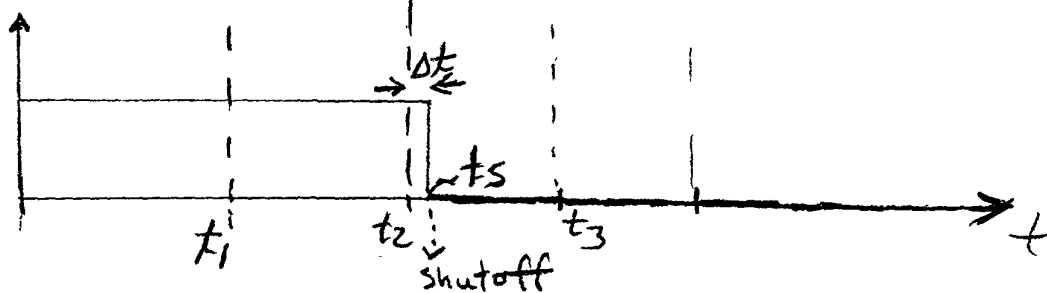
FIG. 2E

Inverter  
shutoff

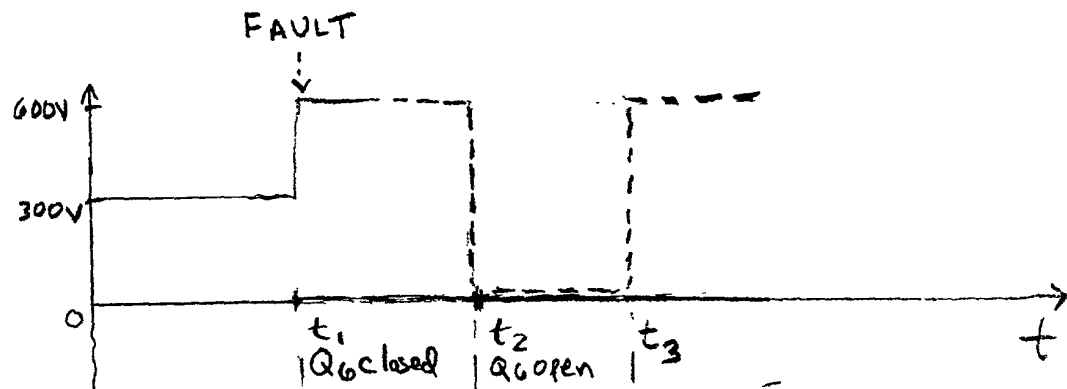
FIG. 3A

(+)DC Link Voltage  
with Respect  
to Chassis

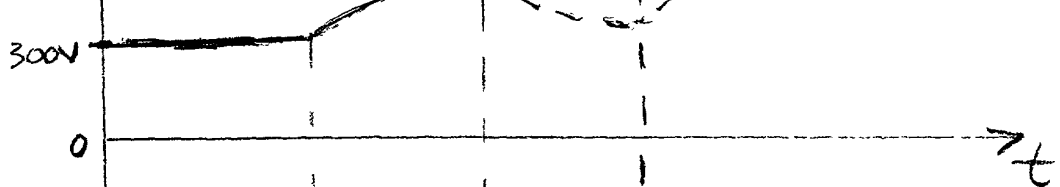
FIG. 3B

$V_{C2}$   
across Capacitor  
 $C_2$

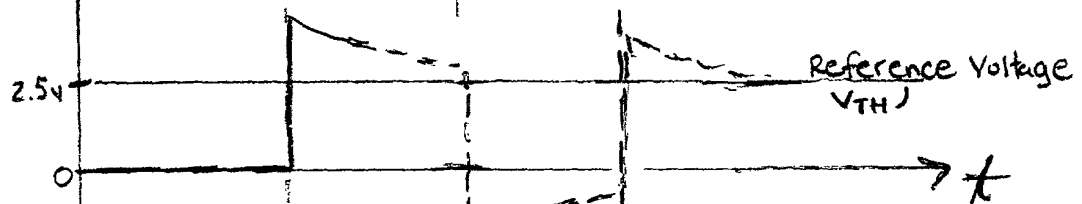
FIG. 3C

$V(t)$   
Comparator  
with Respect  
to Chassis

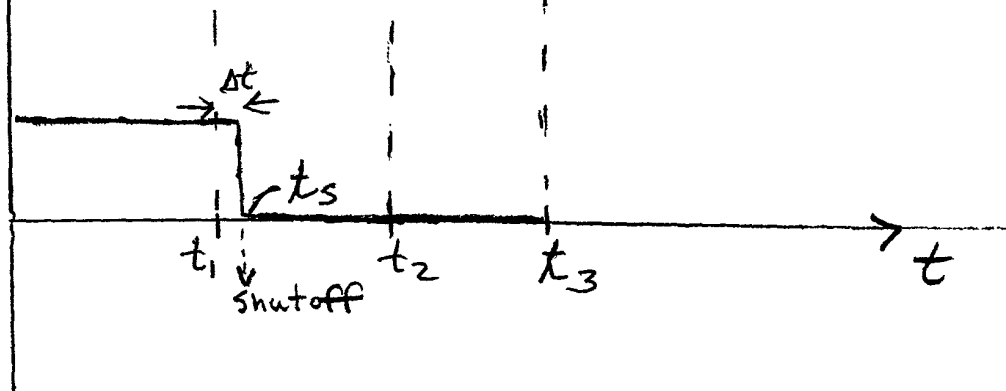
FIG. 3E

Inverter  
Shutoff
